What are the Safety Issues Along CSAH 9?

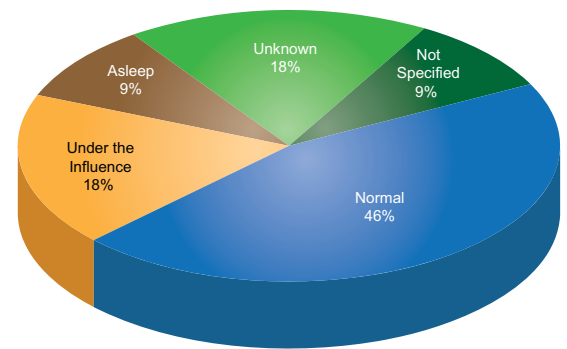
Driver Condition

On CSAH 9, while twenty-seven percent of the crashes were related to driver behavior, most recorded crashes in the last five years have occurred when the motorist was considered to be driving under “normal” conditions (forty-six percent). This data suggests roadway geometrics are a contributing factor to crashes along this segment.

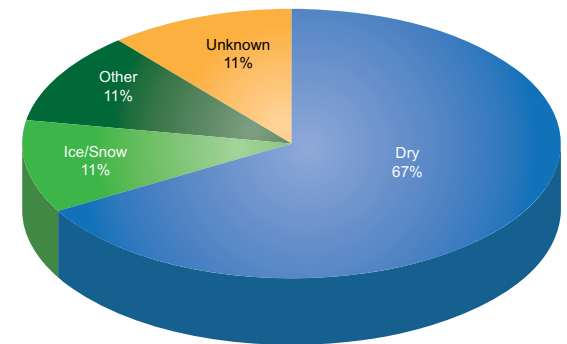
Roadway Surface Conditions

For this segment of roadway, sixty-seven percent of recorded crashes in the last five years have been when the roadway surface was in good driving condition, which further suggests that geometric conditions are contributing to crashes along this segment.

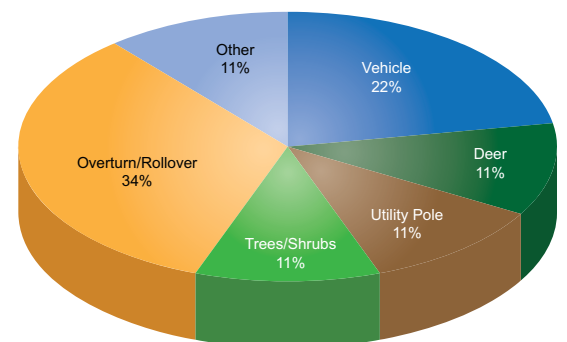
Collision Obstacle

Obstacles that vehicles have collided with appear evenly distributed. However, many of these obstacles suggest that the corridor’s limited right-of-way, narrow shoulders, lack of pedestrian facilities, and steep ditch slopes are contributing factors (i.e. overall geometric conditions).
