Safety Analysis

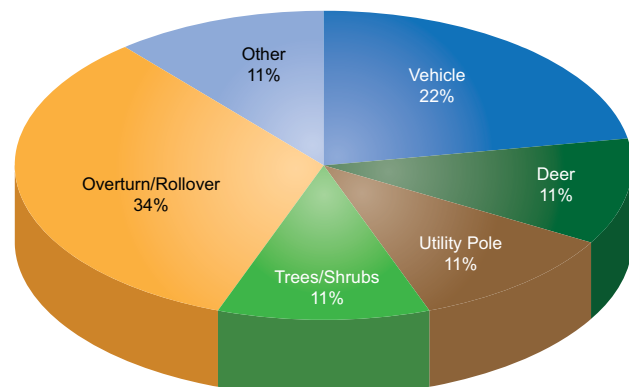
Collision Obstacle

Obstacles that vehicles have collided with appear evenly distributed. However, many of these obstacles suggest that the corridor’s limited right-of-way, narrow shoulders, lack of pedestrian facilities, and steep ditch slopes are contributing factors (i.e. overall geometric conditions).
